Summer 2013 Expedition Report

December 2013

1 DATA-LOGGING BATIMA INSTALLATION

2 DATA-LOGGING MINAZI INSTALLATION

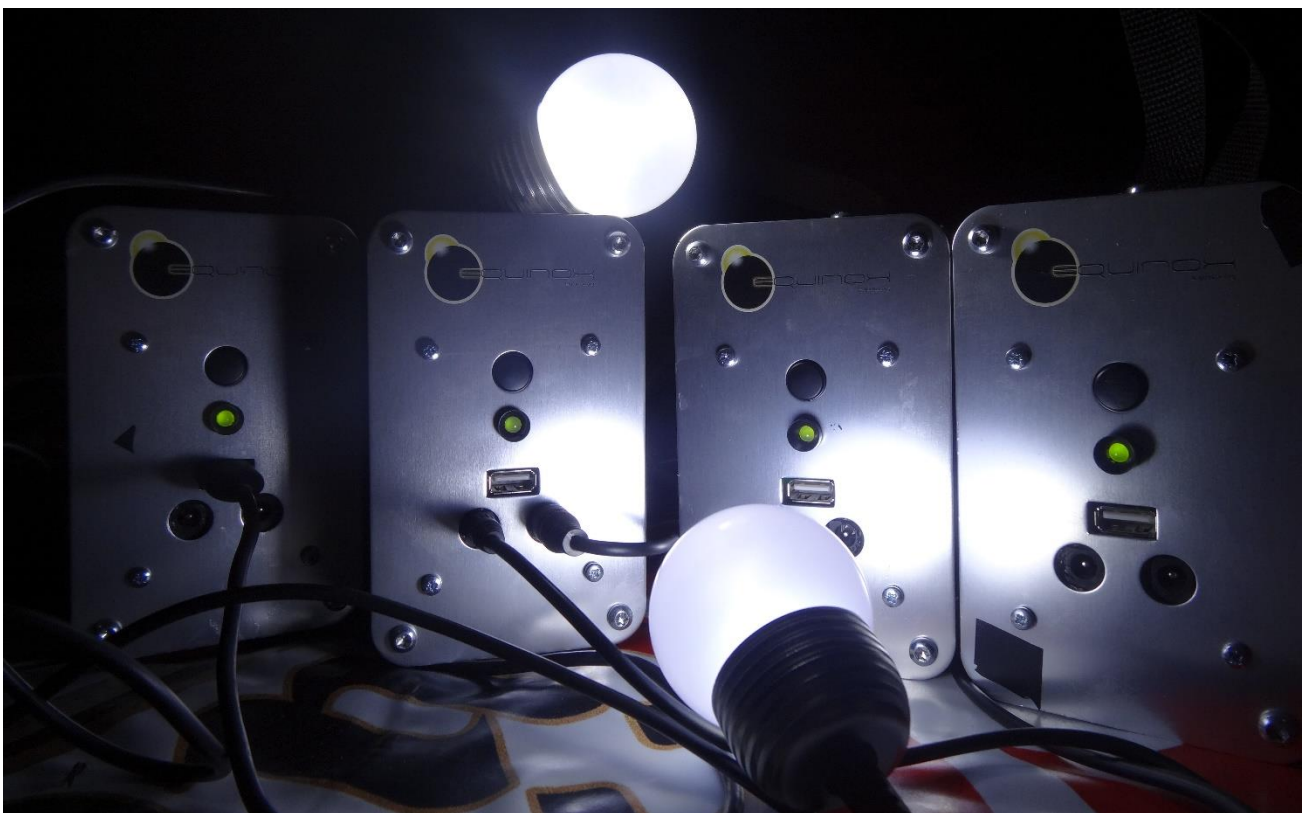
The new design was implemented in September 2013 and achieved a very professional finish. The overall cost of the boxes was higher than the previous years, but this was seen as necessary for the investigation, and could be reduced through refinements and mass production.

Figure 4 2013 Battery Boxes
