Imperial College Student Union

Health and Safety Inspection Report

Conducted on Wednesday, 13th November 2019

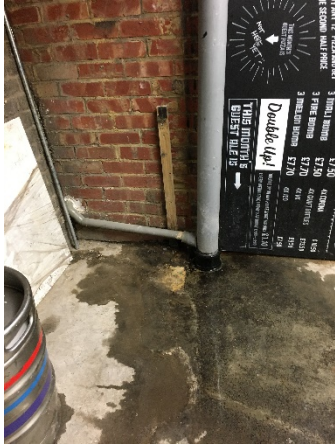
Cellar: Drain pipe has been leaking in the cellar area for some time, but not reported.

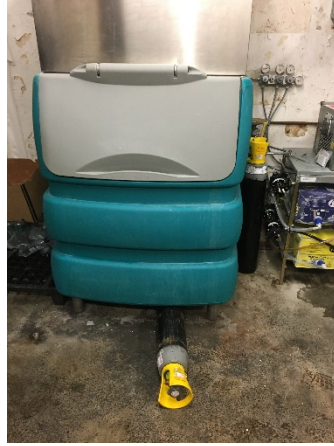
Cellar: CO2 cylinder apparently used to prop up the ice machine.

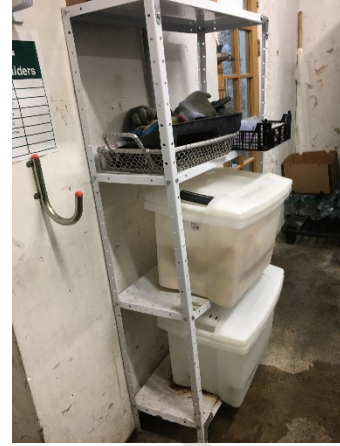
Cellar: Unsecured, overloaded, rusting racking holding boxes of lemons in unsuitable environment.

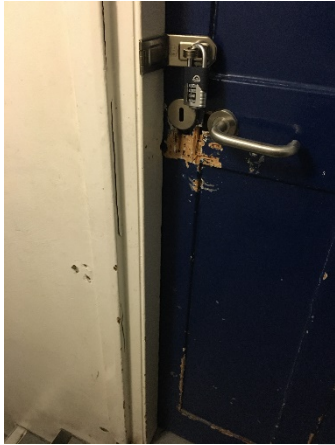
Nightclub area: One of several doors to which the SU has no key and no idea what lay behind, like CX. Are CSPs taking over their own space? If so, this cannot continue.

- a) The SU management (in conjunction with the Building Manager as some risers are included), need to take back control of spaces and keys, and establish a monitoring and inspection programme for areas currently "controlled" by the CSPs.
6. The Student Union building which includes student and hotel accommodation out of Term, is suffering from lack of care and lack of control of students' and other activities within.
 7. In its existing state of repair and with its current standard of operations, there is likely to be a substantial fire risk.

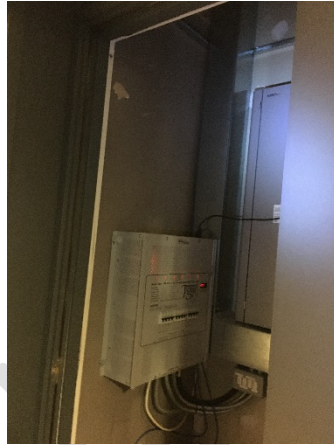
- One riser cupboard at the back of the club - a high-risk Estates plant area - is being used by the CSPs for access to their lighting rig controls.
- The use of deep fat fryers, untrained staff, no fire suppression system and ducts that go through the building is a fire risk.

Nightclub area: Open riser is accessed by CSPs (?) to alter lighting rig controls. This is an Estates Riser containing a distribution board. This is an unauthorised use of a high-risk area.

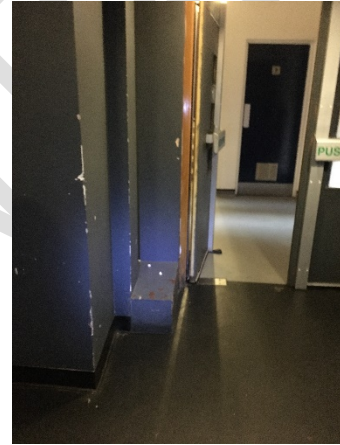
Nightclub area: SU staff aware of custom and practice to wedge open fire doors. Daily check needed, removal of wedge, and discussion with cleaners.

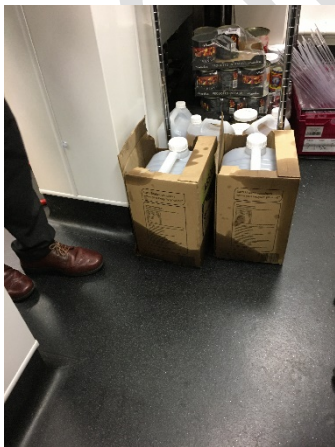
Staff Dining Kitchen: Two 25L drums oil leaking onto floor. Major slip hazard.

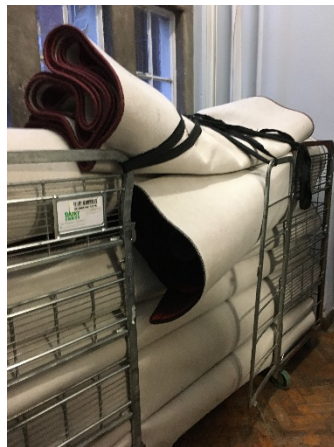
- Housekeeping and uncontrolled fire-loading, is a major concern throughout, particularly in seldom visited rooms and on protected stairwells (where there are prayer mats stored), and in the voids beneath the stages.

Prayer mats in protected stair well outside kitchen with deep fat fryer with no fire suppression system.

- a) Clarity is needed between the Student Union and Estates as to the boundaries of ownership, maintenance, repair and replacement, statutory testing and inspection, and the provision of soft services. This might be via a memorandum of understanding with various arrangements detailed or a service level agreement.
- b) Install suppression systems into the kitchen extract ventilation systems, train staff accordingly.

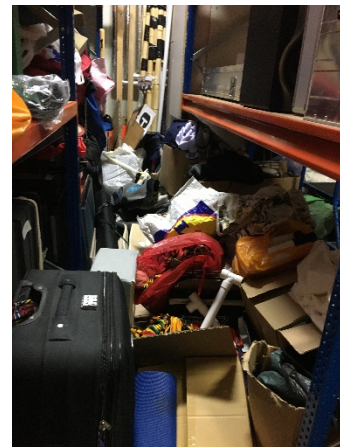
Small store room adjacent to stairwell full of junk which could be used for prayer mats if cleared.

- The concern is that CSPs have taken these over for themselves as in some instances locks have been forced and hasps and staples added. This is a further fire risk, particularly given that the rooms have been filled with rubbish. One specific CSP room if cleared could be used to store the prayer mats.
- Some of the roof doors could be accessed by students or unauthorised persons if the swipe or locks fail. What checks are made for access control, means of escape and fire loading/fire alarms?
- Missing window restrictors - student mental health is a concern, as is access control and the uncontrolled spread of fire.
